The Charles Stark Draper Laboratory

MEMORANDUM

To: Russ Larson
From: Donald Eyles
Subject: Altitude-rate error with EMP 103A
Date: December 1, 1972

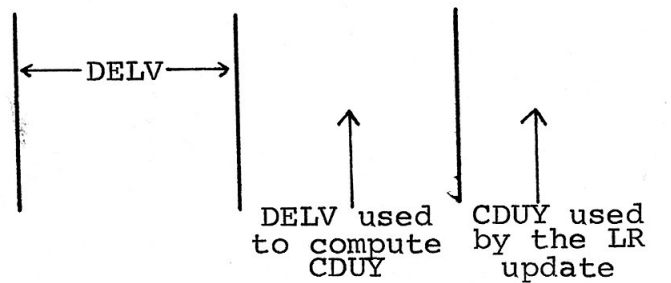
(1) The first stems from the fact that the computed CDUY lags behind the real angle by three seconds. The CDUY computed from the DELV vector is (roughly) valid for the middle of the PIPA interval over which that DELV was accumulated. This angle is computed by the EMP following Servicer during the next PIPA interval, and it is picked up and used by the next Servicer as if it were valid for that PIPTIME. In fact it is valid for a

time about three seconds before that. See the drawing, in which the vertical lines represent PIPTIMEs:

If pitch is flown smoothly during P63 the rate-of-change of pitch is about $-.1^{\circ}/s$, and thus the steady-state error from this source is about $.3^{\circ}$ in the wrong direction, i.e. though the mechanism described above it makes the AGC think the LM is descending more slowly than it actually is, by about 10 f/s. Simulations run at MIT bear out these numbers. For rough maneuvers, as when a man is flying N87, the error is less predictable but probably less because there will be periods when pitch is not changing at all and the velocity vector is being updated accurately.
